KINGSMEADOWS ESTATE,  
PEEBLES

Bat Survey Report

Granton Homes

September 2019

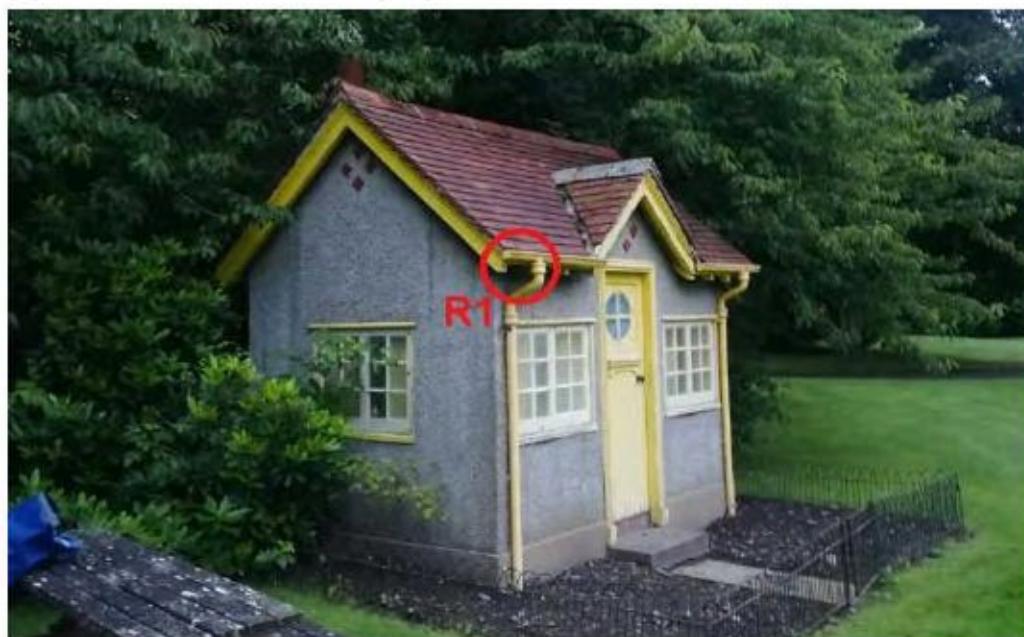
**Figure 1. View of Roost 1 (R1), western corner**

5.3.1 A single soprano pipistrelle (*Pipistrellus pygmaeus*) was observed roosting in Roost 1 (R1) within the shed during dawn on 14.08.19 and dusk on 29.08.19 (Figure 1 and Figure 6).

6.2.3 Kingsmeadows House and the shed both contain bat roosts and as such are protected at all times from disturbance, alteration, and destruction. Both buildings fall within the proposed development envelope. If any works that may cause disturbance to these roosts are to be carried out within 30m of roost access points, an EPS licence granted by SNH and an accompanying Species Protection Plan will have to be in place prior to works commencing.
